Manhole Inspection Summary

Manhole # S41E2_013MH

Insp Date: **12/13/07 7:35 AM**

Location Address: **4200 6th St** Cross Street: **Townsend Ave**

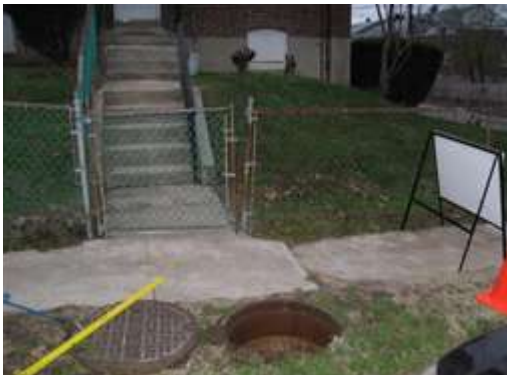
Location View

4200 6th st

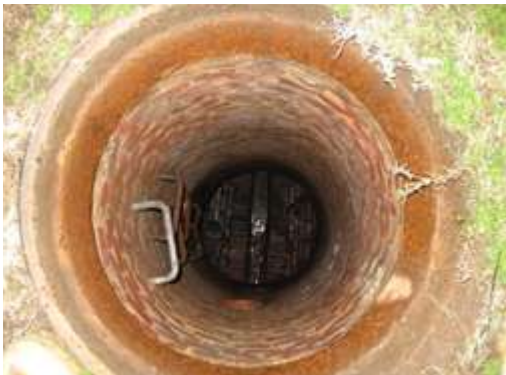
Top View

steps

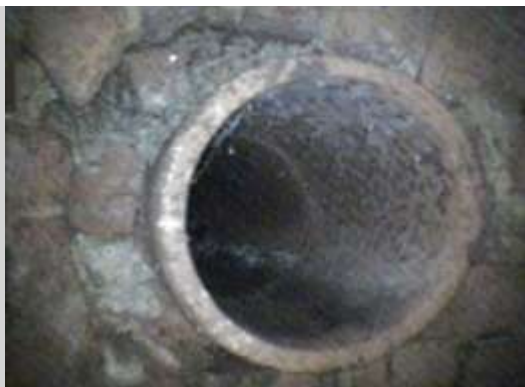
6 O'Clock Inflow

8 in. Circular Gravity Sewer
Pipe In @ 6 O'Clock

Pipe Height: **9.6** (in.) Rod and Bar (Angled)
Pipe Material: **Clay** ☐ Pipe Lined
Invert Depth: **7.66** (ft.) Flow Characteristics: **Fast**
Deposits: ☒ None ☐ Mud ☐ Sludge ☐ Debris ☐ Grease
Silt Depth: (in.) Deposits Extent:
Infiltration: **None** Pipe Seal Cond: **Sound**

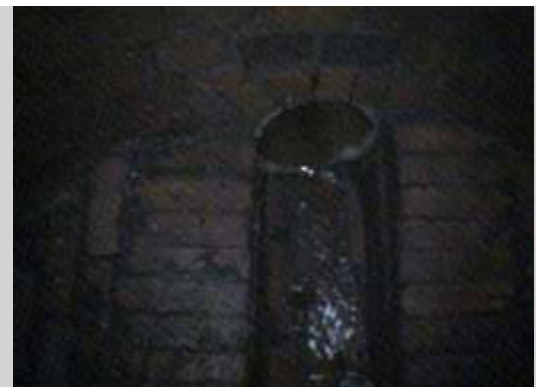
Drop In @ 6 O'Clock

Drop: **Outside** Rod and Bar
Angled: **Yes** Reading: **16.78** (ft.)
Inv Depth: **17.78** (ft.)
Drop Condition: **Open**
